# Report

## Defect Detection on OD of Cylinders

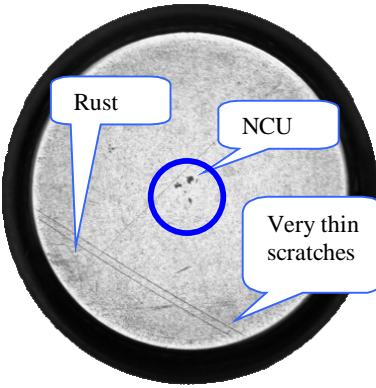
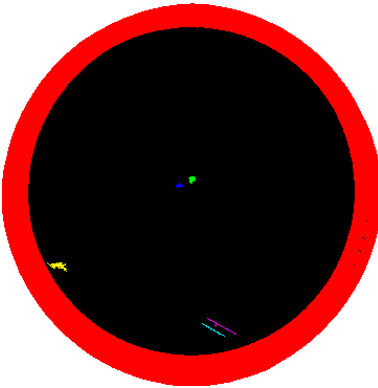
Notes	Raw Image	Defect Overlay
<p>Sample 01 Expected Defect: NCU</p> <p>NCU shows up as pits in the center of the end. Two of three such pits were large enough to be detected as shown in overlay at right.</p> <p>In addition, we detected small rust area and 2 very thin scratches. The width of the scratches was only about 0.0005", so they were not have counted as defects.</p>

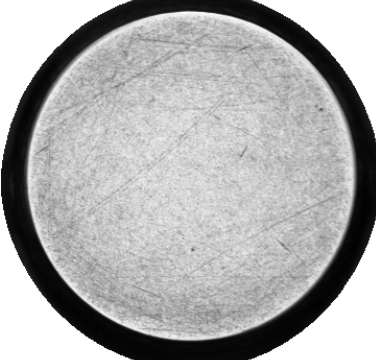
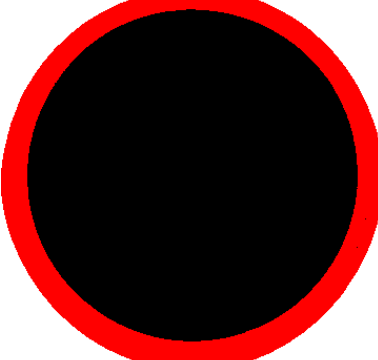
<p>Sample 02 Expected Defect: Good</p> <p>No defects detected.</p>

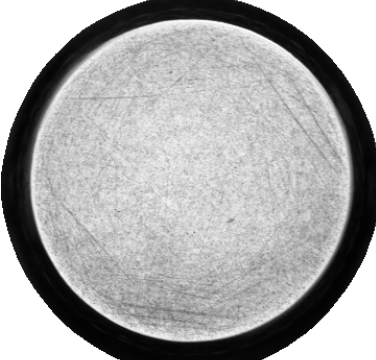
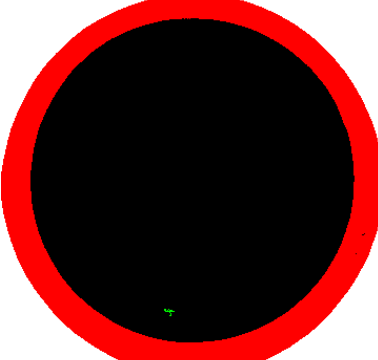
<p>Sample 03 Expected Defect: Good</p> <p>One small defect detected. Size of defect was only 0.005" in diameter. A single pit of 0.010" is allowed.</p>

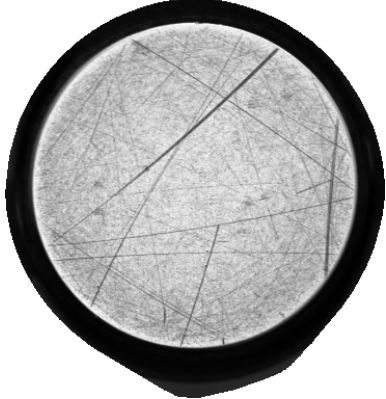
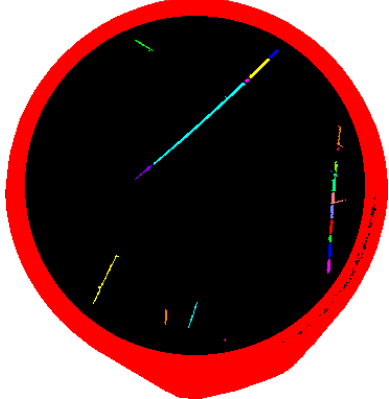
Notes	Raw Image	Defect Overlay
<p data-bbox="267 258 578 317">Sample 39 Expected Defect: Grind line</p> <p data-bbox="235 348 597 590">The two widest scratches measure about 0.0015" wide, at the widest point. There are clearly several other scratches. Using the scratch processing in FiberQA, we could identify and measure each scratch visible in this image</p>
