Case Study – Water Pump Shaft Inspection

Customer Problem

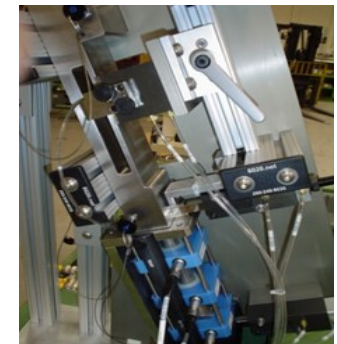
Figure 1 - Water Pump Shafts and Eddy Current Coils

The testing station contained three independent eddy current encircling coils which provided the ability to test in three specific areas. A second set of eddy current coils with a known good shaft was used as an external reference.
